**ACTION MEMORANDUM**

**SUBJECT:** Confirmation of Verbal Authorization for a Removal Action and Request for 12-Month Exemption and Ceiling Increase at the Barry Bronze Bearing Company Site, City of Camden, Camden County, New Jersey

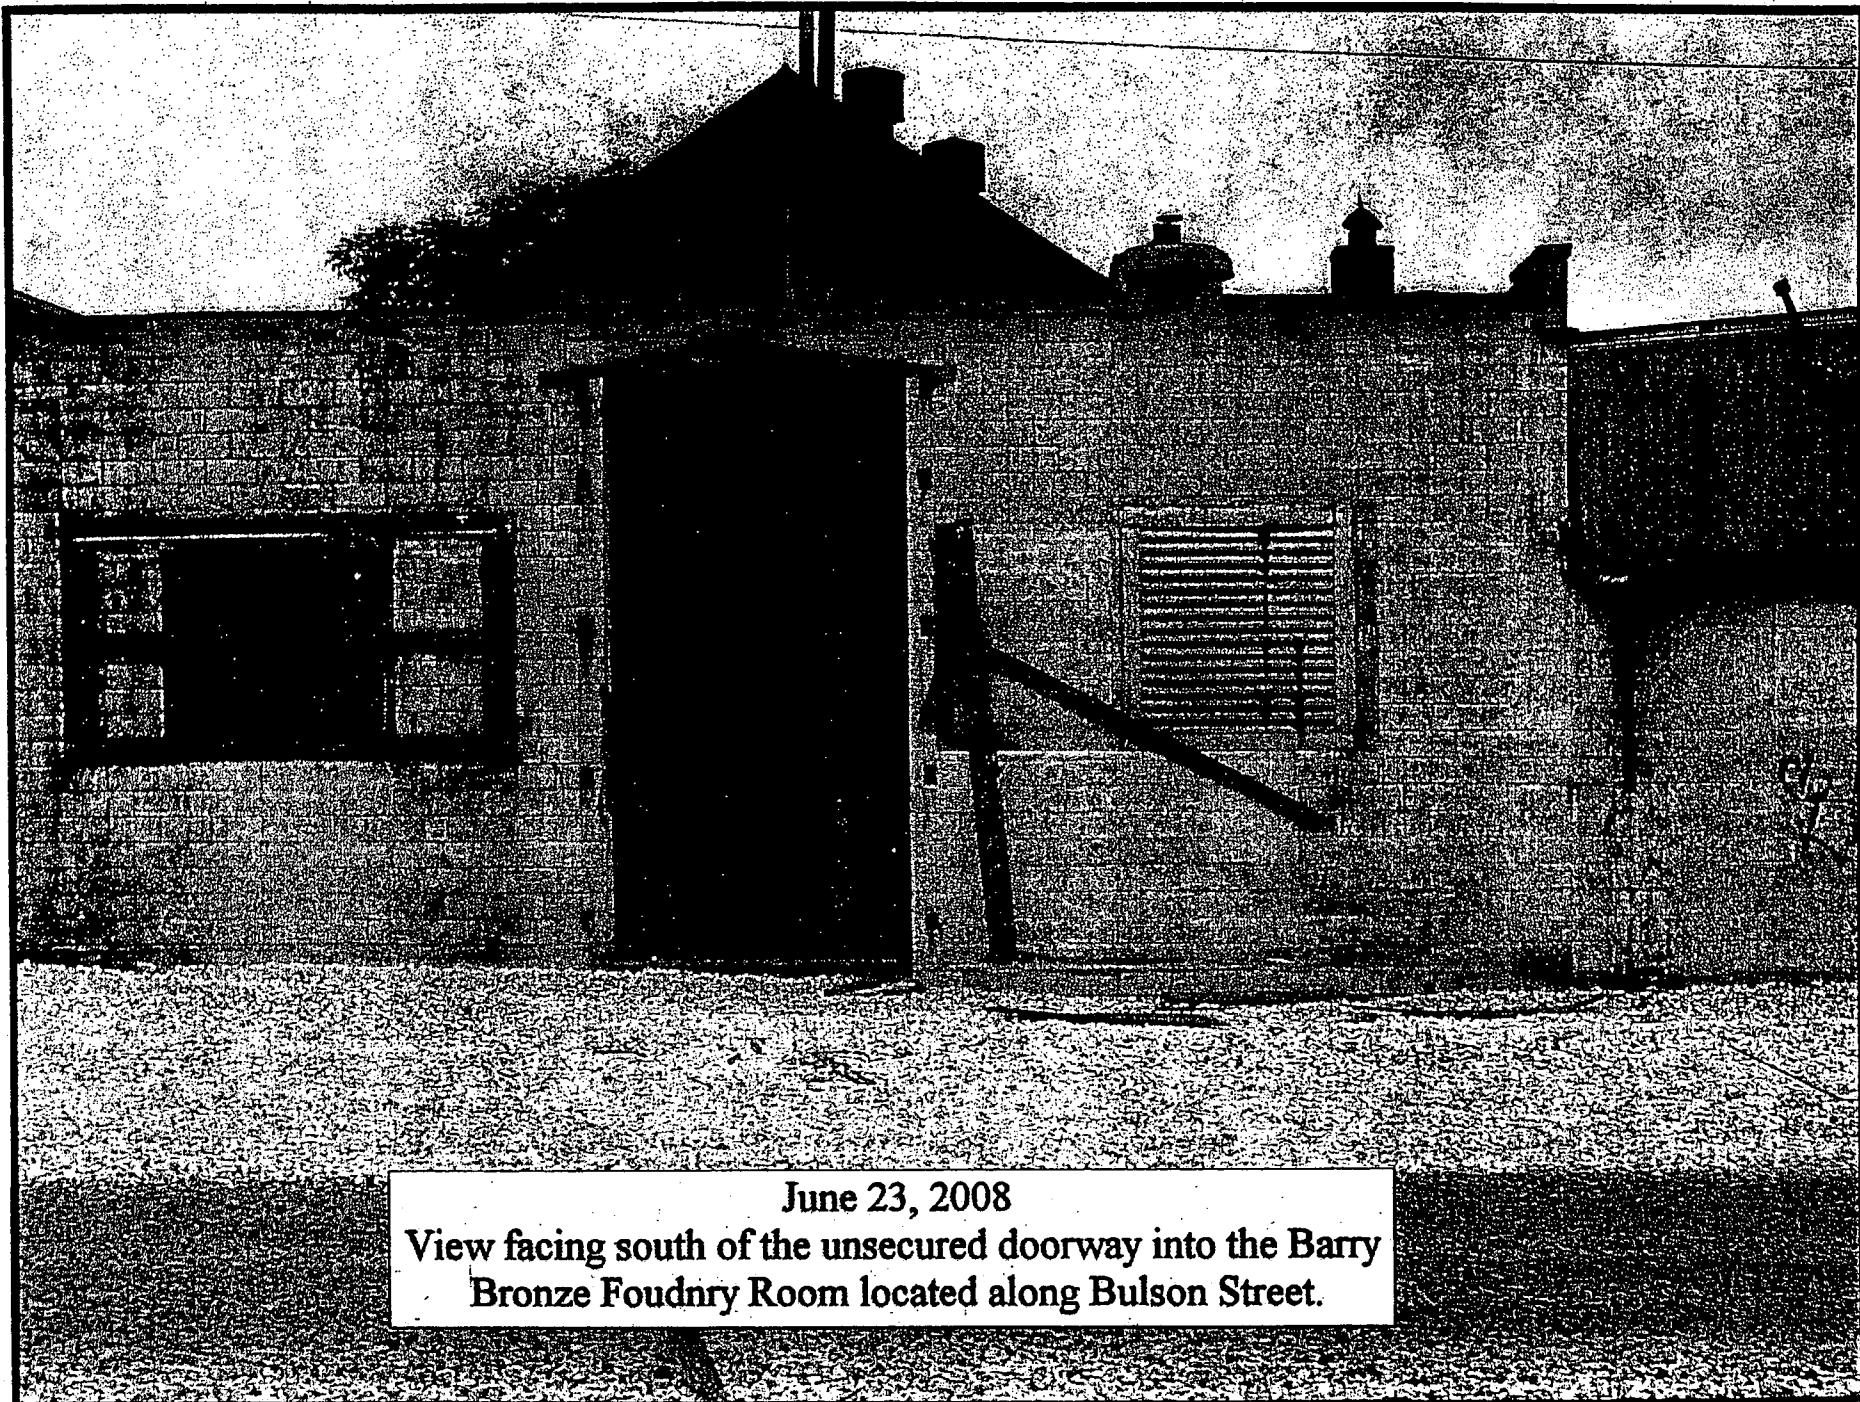
The large door which was opened by vandals along Bulson Street, was a conspicuous access point into the facility and leads directly into the foundry room which houses the most significant lead contamination. Neighboring residents reported that children were entering the facility through the open door. Trash observed inside the building indicated that trespassers were entering the building on a frequent basis since the door has been opened. The rapid release of water inside the facility is running into the foundry room. A large portion of the foundry area floor consists of foundry sand. Foundry sand filling this area gives way to native sandy surface soils. Any water which runs into this area has the potential to carry dissolved lead or physically transport fine lead particles out of the facility into the environment.

June 23, 2008  
View facing south of the unsecured doorway into the Barry  
Bronze Foundry Room located along Bulson Street.

The purpose of this removal action was to eliminate the threat of direct contact with lead posed to the public and environment. To mitigate the threats posed by this Site, EPA has boarded up broken windows, chained security grates to intact window frames and secured doors and gates using padlocks and chains. Water from the ruptured water line was directed to a nearby drain in lieu of the lead contaminated foundry area while the water service line was located. Due to the absence of a typical shut-off valve, EPA excavated

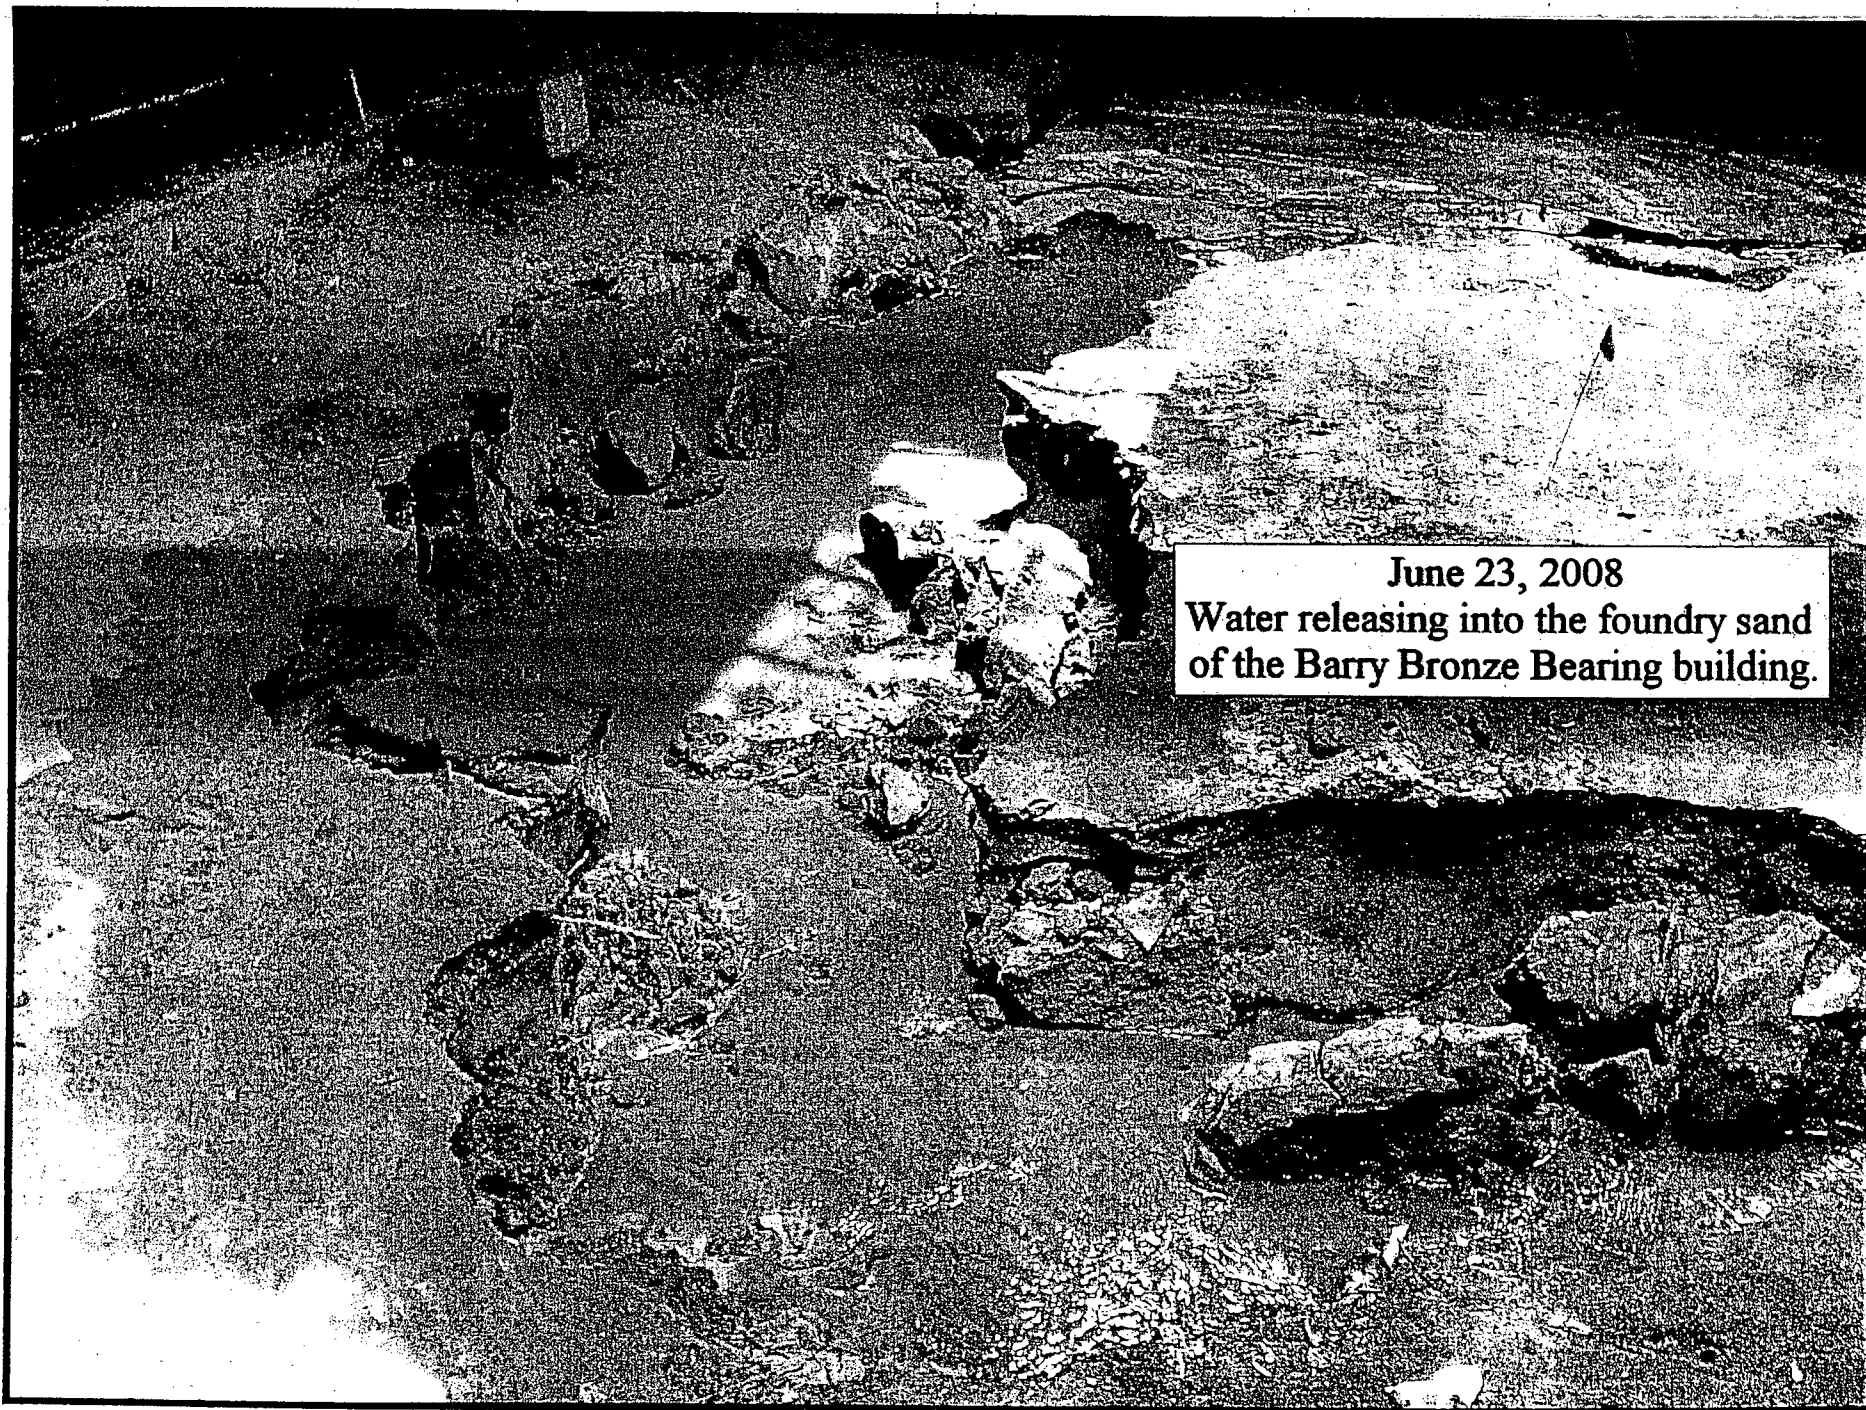
Trespassers stole piping from within the facility leaving a ruptured 1¾ inch copper water service line draining inside the facility at a high rate. Water was observed running inside the foundry into a large rectangular area which is not underlain by concrete and contains lead contaminated foundry sand. The water filled the five foot deep depression in the foundry sand where an underground storage tank had been removed. During the April 2004 RSE, TCLP results obtained from foundry sand contaminated soil collected along Bulson Street, indicated that this material was a RCRA characteristic waste. Although it is unclear whether the water was percolating into the subsurface or had reached another exit point, lead contaminated sand and/or dissolved lead may have released into the environment.

Vandalism at the previously secure facility resulted in the rupture of a water line in the facility. The mechanism for release of hazardous substances from the Site was through the discharge of potable water through the foundry area out of the facility, into the environment. The open doorway to the foundry also was a pathway for release of lead contaminated dust to exterior public areas.

June 23, 2008  
Water releasing into the foundry sand  
of the Barry Bronze Bearing building.

the parking lot of the facility in order to locate the water service line. Once located, the water was shut-off at the water main. A shut-off valve box was installed so that water service can be restored if necessary. No disposal efforts were taken during this action. No post removal site controls are required at the Site.
